CONNECTICUT RIVER BASIN
WINCHESTER, CONNECTICUT

CRYSTAL LAKE DAM CT 00104

PHASE I INSPECTION REPORT NATIONAL DAM INSPECTION PROGRAM

AUGUST, 1979

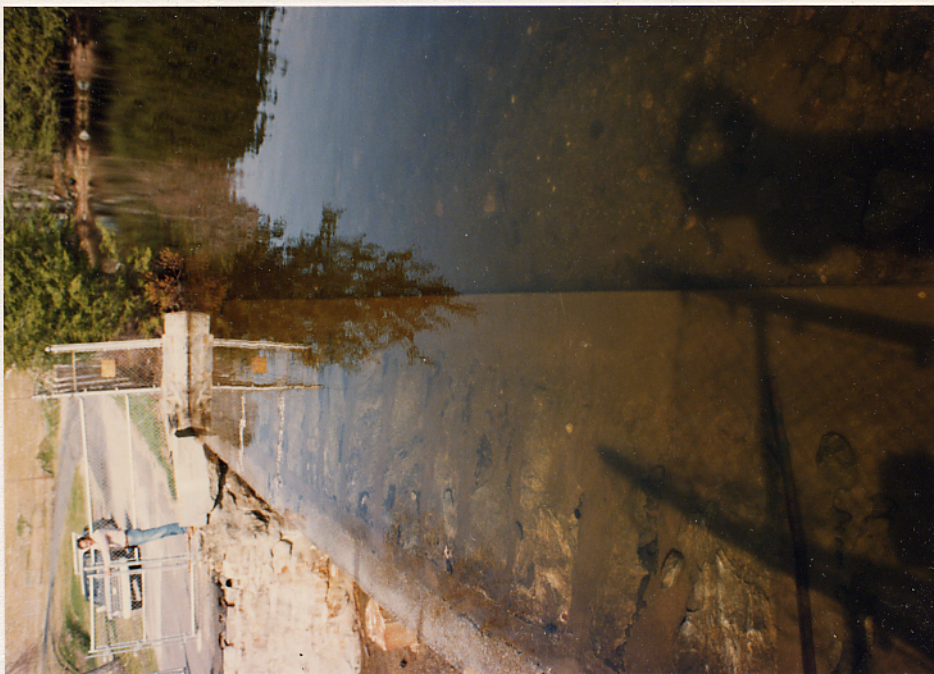
Upstream Slope - The slope protection is riprap and a grass cover at the crest. No erosion or sloughing was observed, however trees of 4 to 6 inches in diameter were noted (Photo 1).

Photo 1 - Crest of embankment and spillway from left spillway training wall. Note trees on upstream slope of embankment and deterioration of upper right training wall (May 1979)

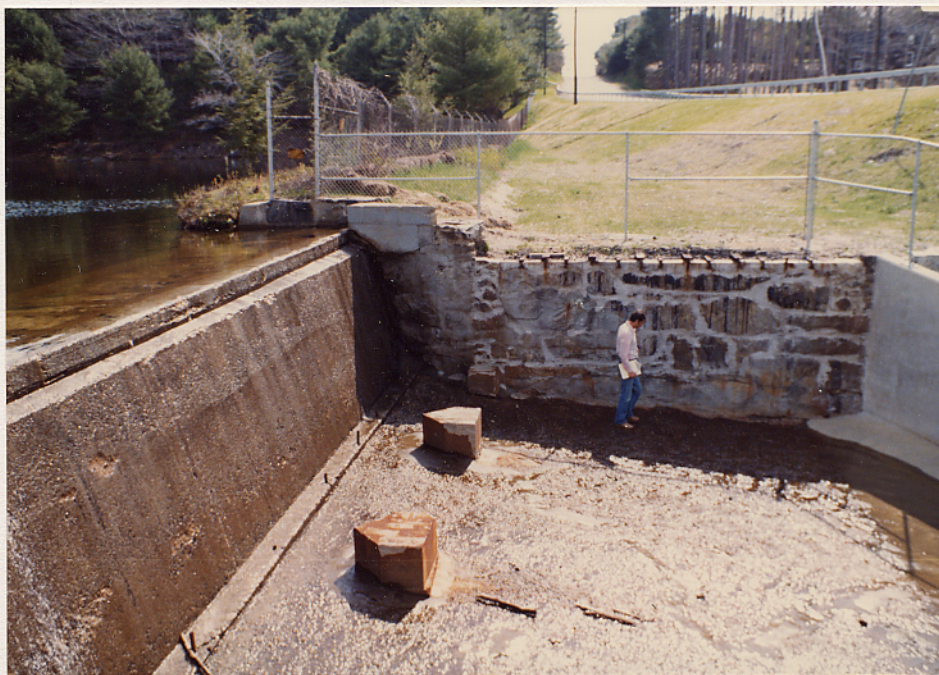
Spillway - The 45 foot long and 8 foot wide ungated spillway is a concrete structure with a concrete apron, concrete dissipators and stone masonry training walls. Deterioration of the concrete with spalling and exposed aggregate was observed on the downstream face of the spillway weir and the spillway apron (Photos 1 and 2). Lime deposits and wet areas on the mortar joints were noted on both training walls (Photos 2 and 4).

Photo 2 - Left embankment and spillway from right spillway training wall. Note deteriorated concrete on downstream face of spillway weir and efflorescence on left spillway training wall (May 1979)

4. Seepage at the downstream slope near the right abutment should be monitored periodically for measurement of flow rate.
5. Deteriorating concrete of the spillway weir and apron should be repaired.

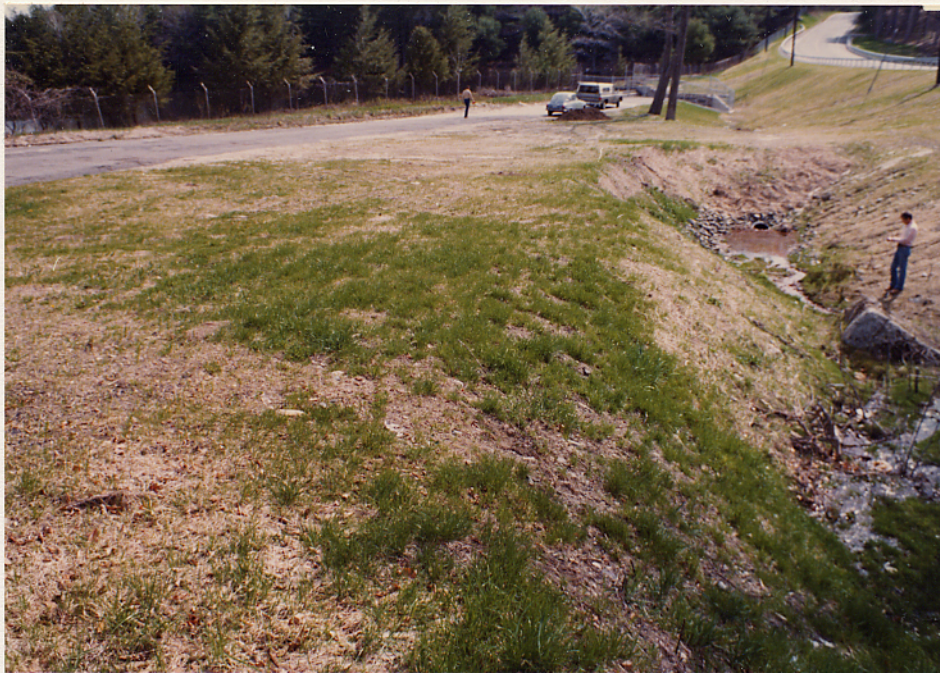
No erosion or cracks were observed on the downstream slope of the embankment. There is an extensive wet area along the downstream slope near the right abutment approximately 5 to 6 feet below the crest, with a total seepage flow from this area to the swale of approximately 5 to 10 gallons per minute (Photo 3). There was some brown silt deposits at the outlet of the 18 inch RCP exiting at the right spillway wingwall (Photo 3).

Photo 3 - Crest of right embankment and swale between dam and route 263. Note seepage from embankment (May 1979)

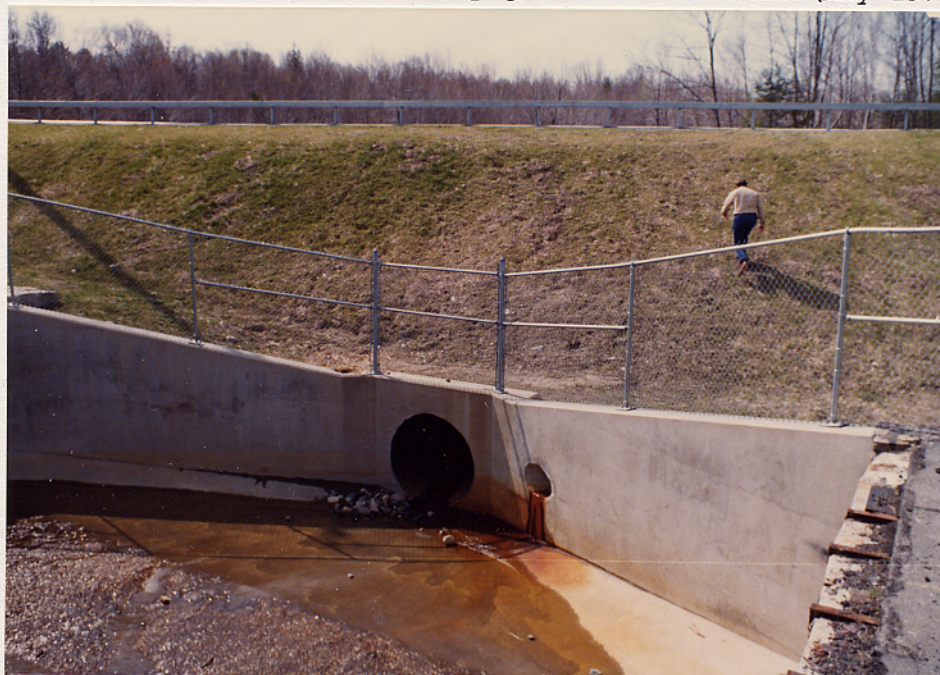
Photo 4 - Culvert intake, drain pipe outlet and concrete head wall from spillway apron. Note brown silt deposits from drain pipe (May 1979)
